WARTIME REPORT

ORIGINALLY ISSUED
December 1945 as
Memorandum Report E5K29

PROCESS OF LEAD-DEPOSIT ACCUMULATIONS ON
AIRCRAFT-ENGINE SPARK PLUGS

By J. L. Sloop, George R. Kinney, and William H. Rowe

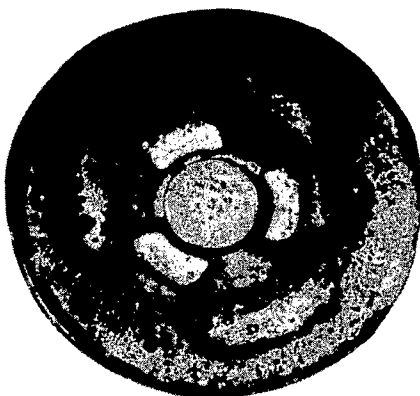
NACA
C-13643
11-15-45

Figure 5. - Accumulation of deposit on a type B spark plug in exhaust position of V-1710 cylinder. Engine speed, 2000 rpm; manifold pressure, 30 inches mercury absolute; fuel-air ratio, 0.10; inlet-air temperature, 85° F; coolant temperature, 250° F; fuel, AN-F-28 with tetraethyl lead content increased to 18 milliliters per gallon (I-T mix).

Accumulation of deposit masses. - The accumulation of deposit with time in the exhaust spark plug of the converted V-1710 single-cylinder engine is shown in figure 4. The engine was operated at cruise conditions with fuel containing 18 ml TEL per gallon. During the test, the development of deposit on the spark plug was photographically recorded. The photographs, which were taken each time the spark plug was removed from the engine for weighing, are shown in chronological order in figure 5. The spark plug is shown in the same orientation in all photographs, the orientation being approximately that which occurred in the engine. The photographs of figure 5 indicate that a large portion of the deposit existed during engine operation in the form of molten globules, which changed position under the influence of gravitation and molecular forces and, possibly, forces arising from gas flow within the combustion chamber. As the total deposit became large after long operation, the concentration of deposit near the lowest point of the spark-plug cavity became pronounced.

Observations of deposits on many spark plugs at the Cleveland laboratory have shown that the appearances and characteristics of deposits formed under different conditions may be quite different. It is therefore impossible to designate any particular deposit typical; deposits similar to those of figure 5 have, however, been observed on badly fouled spark plugs from engines in service use.
